Photographs for Black Eagle Estates

Inspection Type: Construction-Stormwater

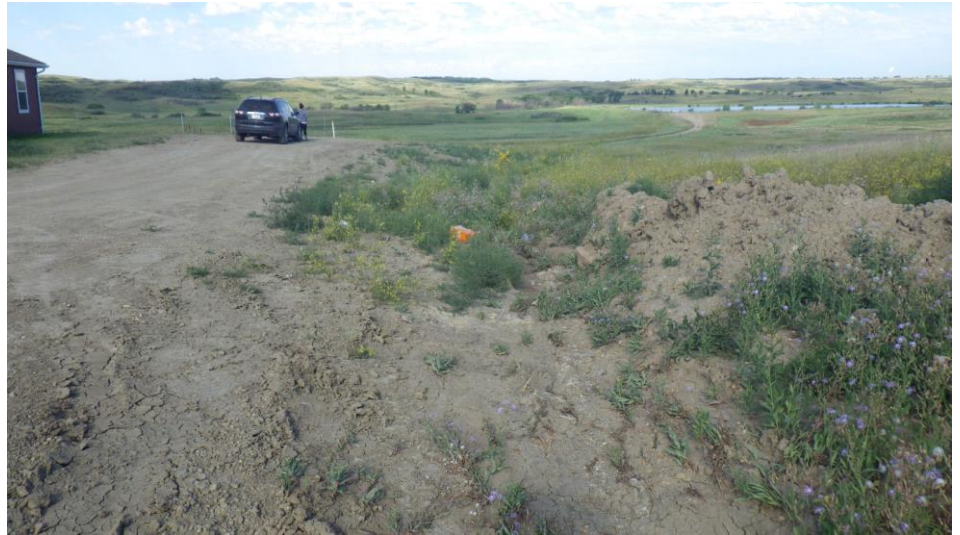
Photo Number: 428
Photo Date/Time: 7/22/2015
Photographer: Kacy Sable
The direction of the photo is West.

A drainage swale by the road on the south side of the subdivision. The Mandaree wastewater lagoon is shown on the far back of the photo.

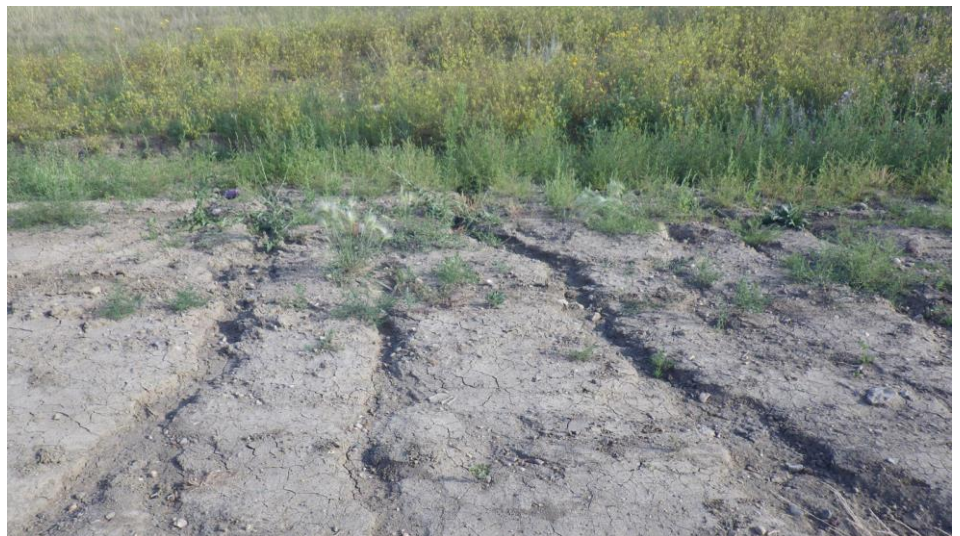
Photo Number: 429
Photo Date/Time: 7/22/2015
Photographer: Kacy Sable
The direction of the photo is North.

Erosional rills observed while walking down from where photo 428 was taken. Note the lack of stabilization.

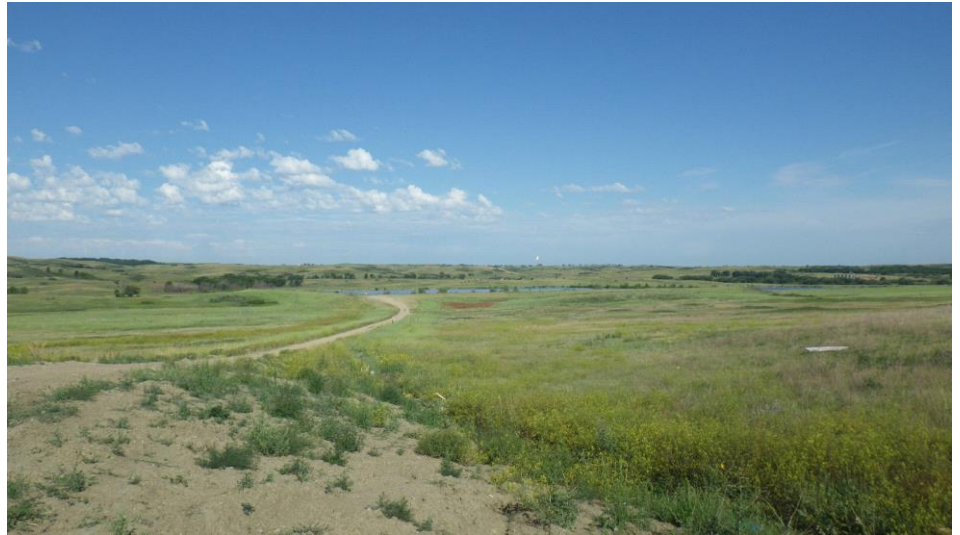
Photo Number: 431

An overview of the northern side of the subdivision.

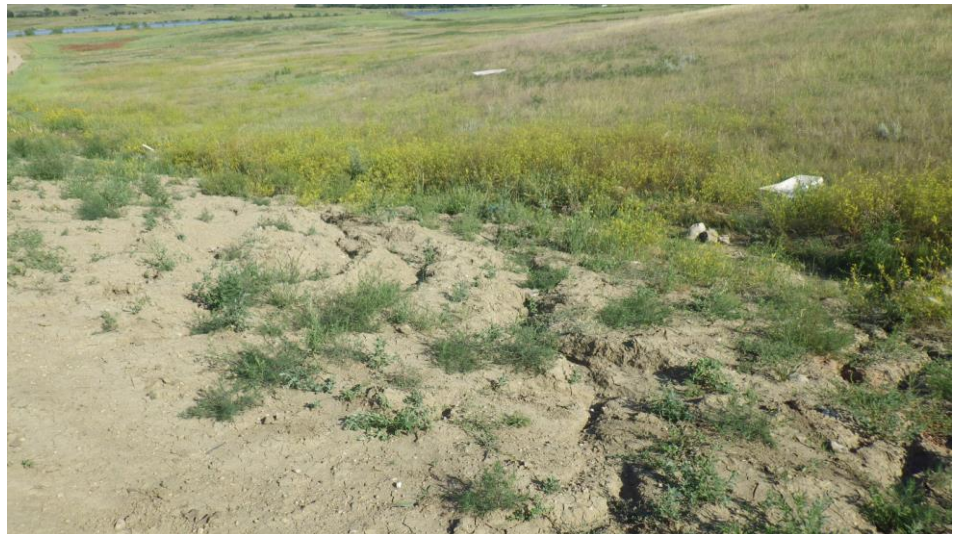
Photo Number: 432

More erosional rills on the northern side of the subdivision.

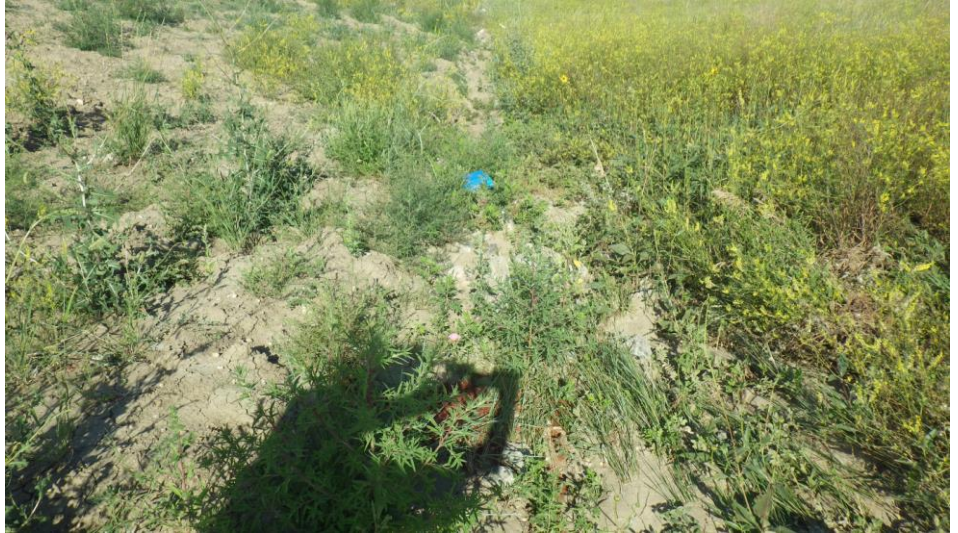
Photo Number: 433
Photo Date/Time: 7/22/2015
Photographer: Kacy Sable
The direction of the photo is West.

A view at the head of the drainage swale.
Note the bent over plants and the sediment.

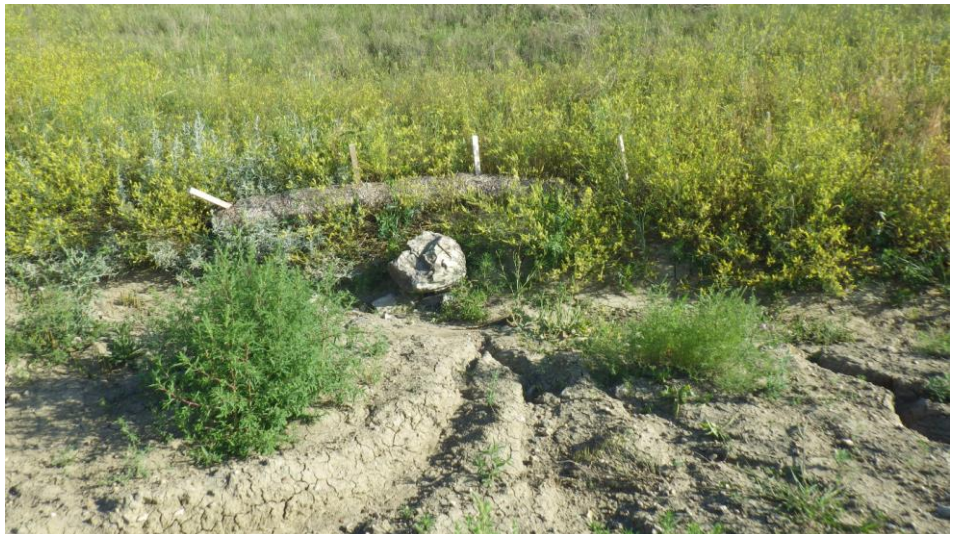
Photo Number: 434
Photo Date/Time: 7/22/2015
Photographer: Kacy Sable
The direction of the photo is Northeast.

More erosional rills on the northern side of the subdivision. Note the straw wattles at the banks of the drainage swale. The drainage swale runs parallel to the road on the northern side of the subdivision.

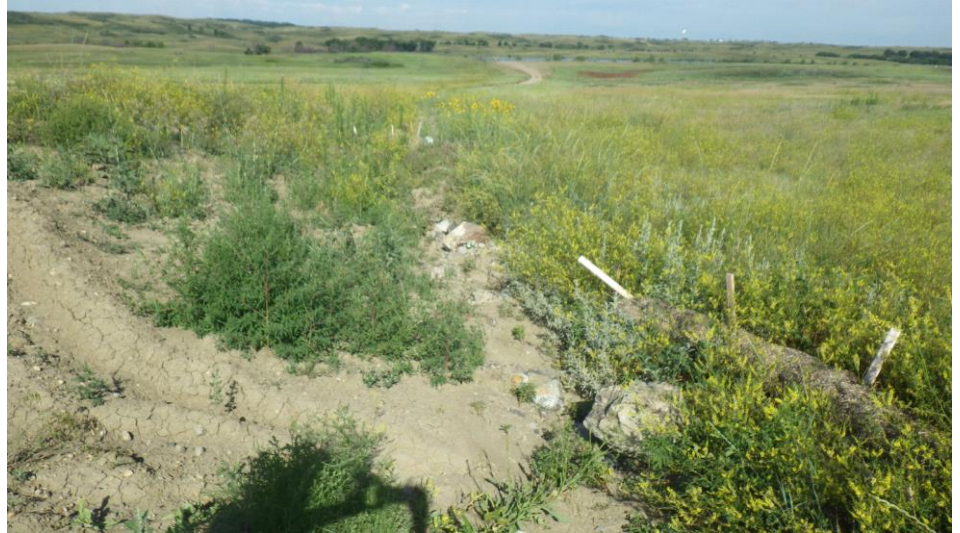
Photo Number: 435

Another view of the drainage swale shown in photo 434.
